**CAPE
COD
EASTERLY
SHORE
BEACH
EROSION
STUDY**

VOLUME I
APRIL 1979

4. TITLE (and Subtitle) (6) Cape Cod Easterly Shore Beach Erosion Study, Volume I. Main Report.		5. TYPE OF REPORT & PERIOD COVERED Beach Erosion, Early History to 2029

CAPE COD EASTERLY SHORE BEACH EROSION CONTROL STUDY MAIN REPORT

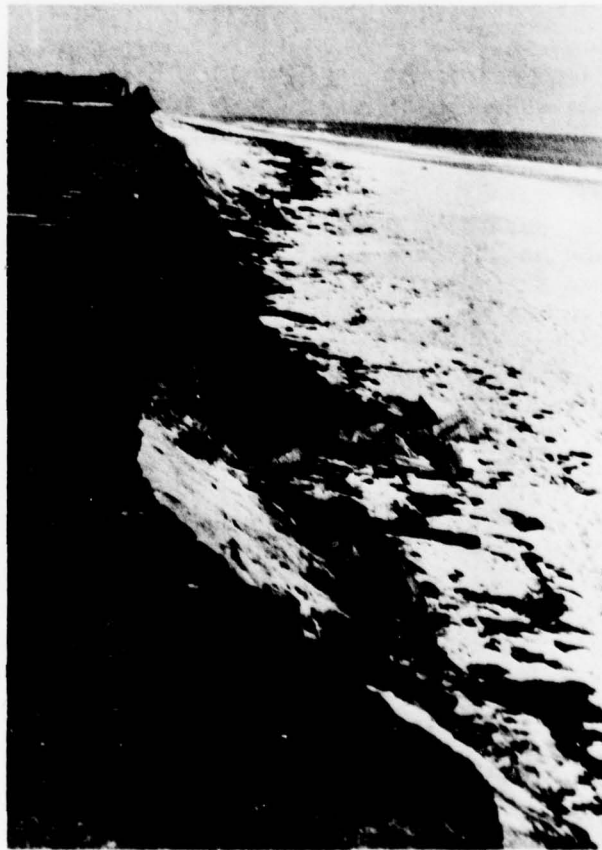
Figure 6. Erosion of the parking lot at Coast Guard Beach, Eastham, Massachusetts

Structural solutions were also implemented at Coast Guard Beach, Eastham. Between 1966 and 1972, rubble was placed in front of the parking lot and bathhouse in an attempt to slow the erosion. The rubble appeared to accelerate erosion in adjacent areas and it became a hazard to swimmers, necessitating its removal. In February 1978, the beach was leveled by a northeaster and the bathhouse and parking lot were damaged. The bathhouse was subsequently removed.

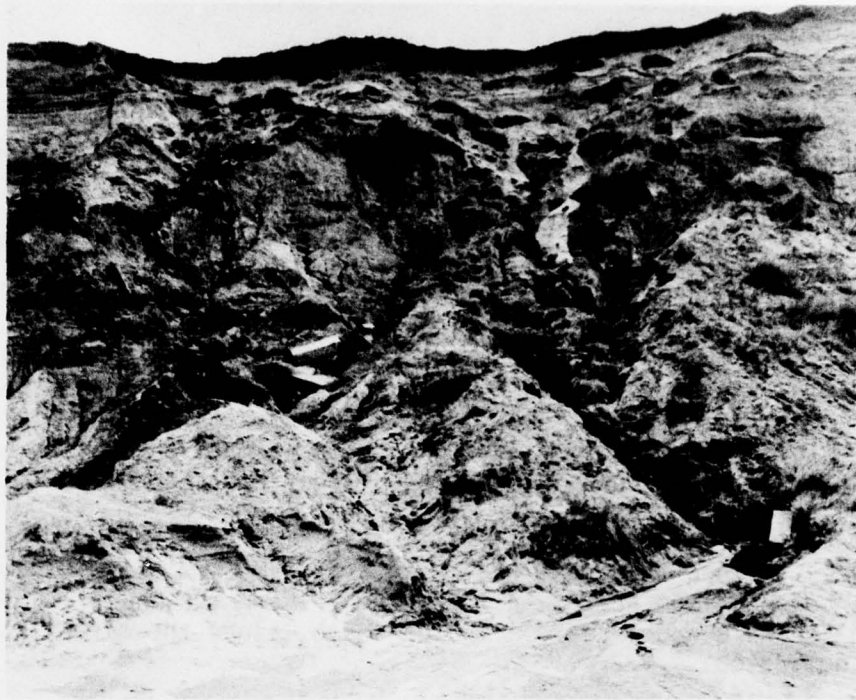
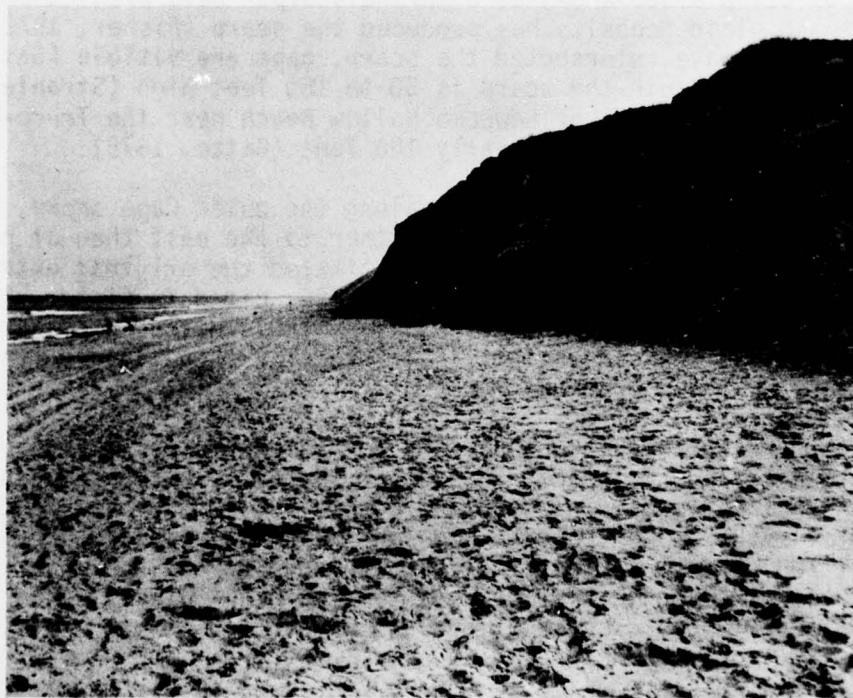
Figure 7. Erosion of the marine scarp, Atlantic coast of Cape Cod, Massachusetts

Recession of the scarp on eastern Cape Cod is caused by erosion of the glacial material on the face of the scarp. Two major factors contributing to the erosion are wave attack on the base of the scarp and erosion of the scarp face by rain and runoff. Rain causes deposition of small fans of clay and gravel at the foot of the scarp (Zeigler, 1960). This material

can then be carried out to sea by waves. Whether waves are able to reach the scarp or the material deposited at the scarp base depends on the condition of the beach. A wide beach protects the scarp base from waves; when the beach is wasted, waves attack the scarp directly (Zeigler et al, 1959).

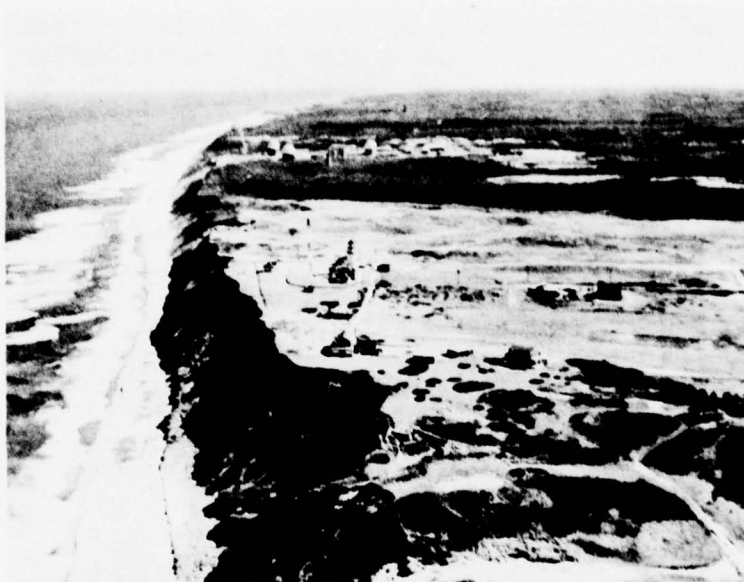
Figure 8. Erosion of the marine scarp, Atlantic coast of Cape Cod, Massachusetts

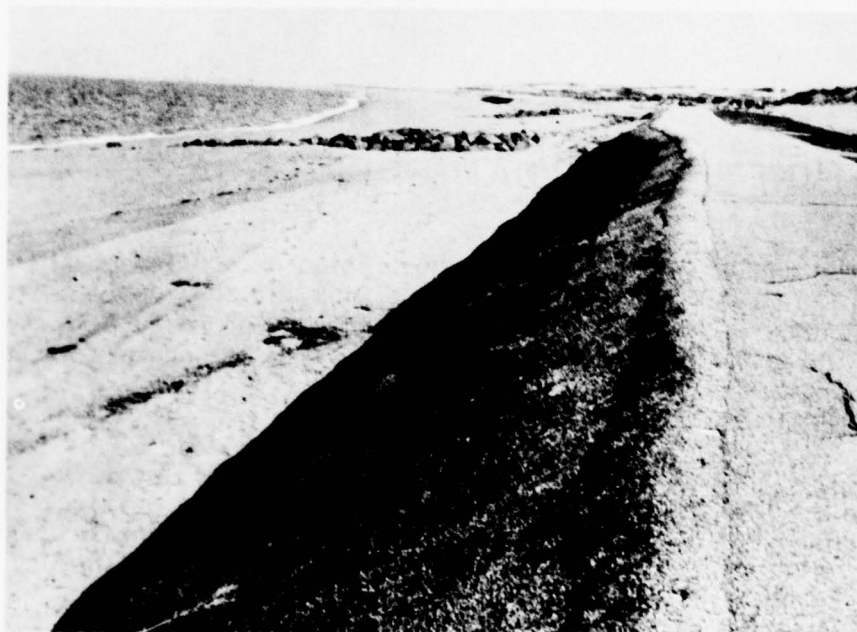
Figure 12. Asphalt seawall and groins at Herring Cove Beach, Provincetown, Massachusetts

At Herring Cove Beach, Provincetown, an asphalt seawall has been constructed. This structure is presently crumbling at its southern end. Four groins located at Herring Cove Beach are in disrepair and provide little protection from erosion.

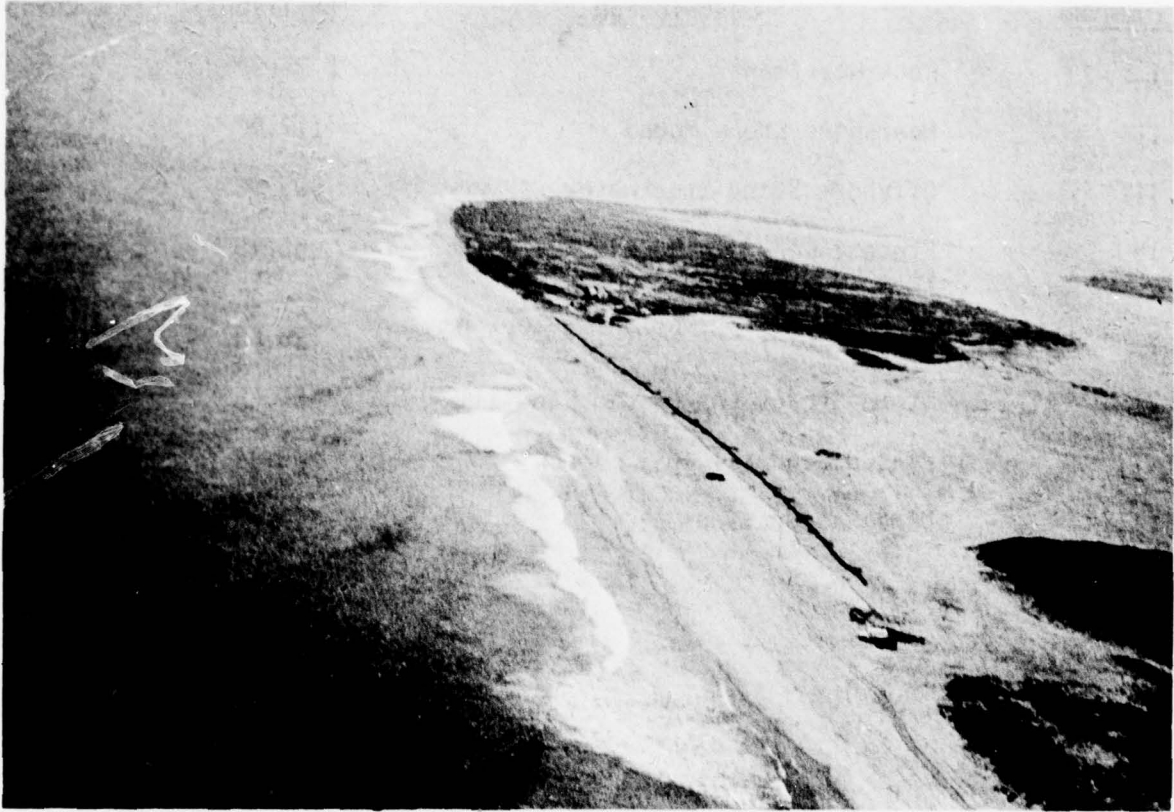
Figure 13. Sand fence experiment near Old Harbor Life Saving Station site, Chatham, Massachusetts

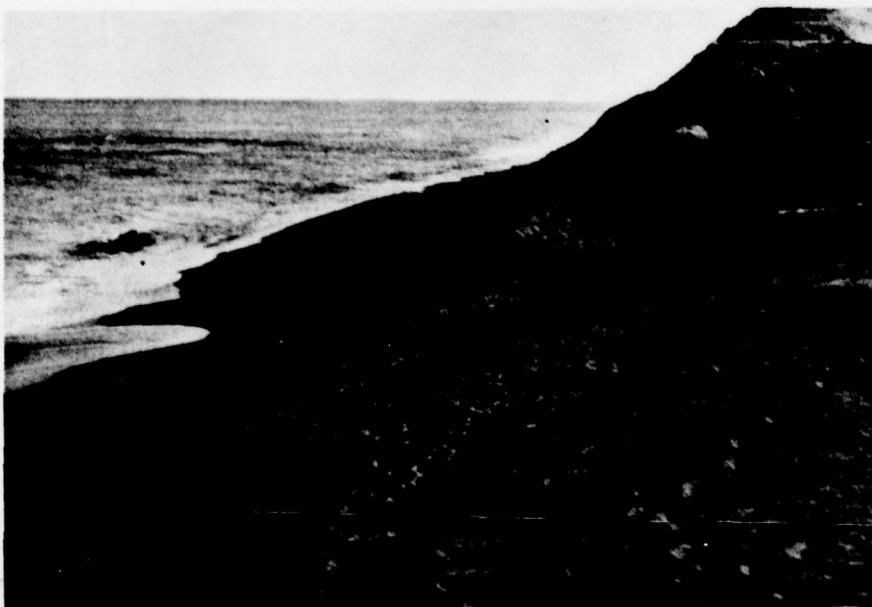
Figure 14. Evidence of foot traffic on the dunes and scarp face, Cape Cod, Massachusetts
